USDA Forest Service
General Technical Report INT-5
1973

**ANALYSIS OF CONSTRUCTION
AND INITIAL PERFORMANCE
OF THE CHINA GLENN ROAD,
WARREN DISTRICT,
PAYETTE NATIONAL FOREST**

W. S. Hartsog and M. J. Gonsior

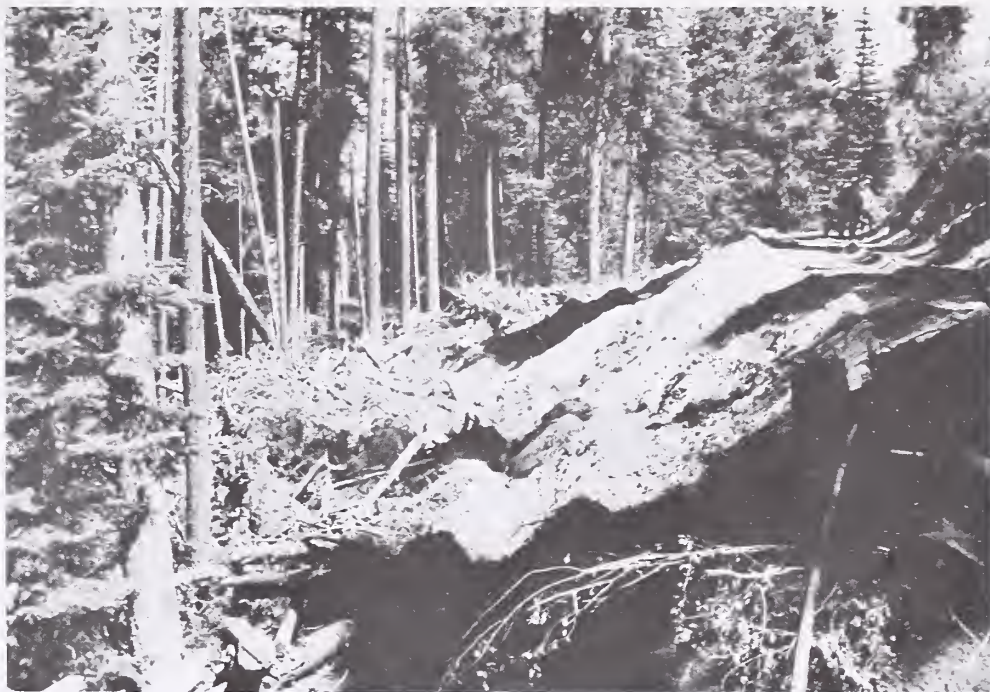
*Figure 1.--Pioneer road
built to facilitate
clearing steep terrain.
Note soil mixed with
slash.*

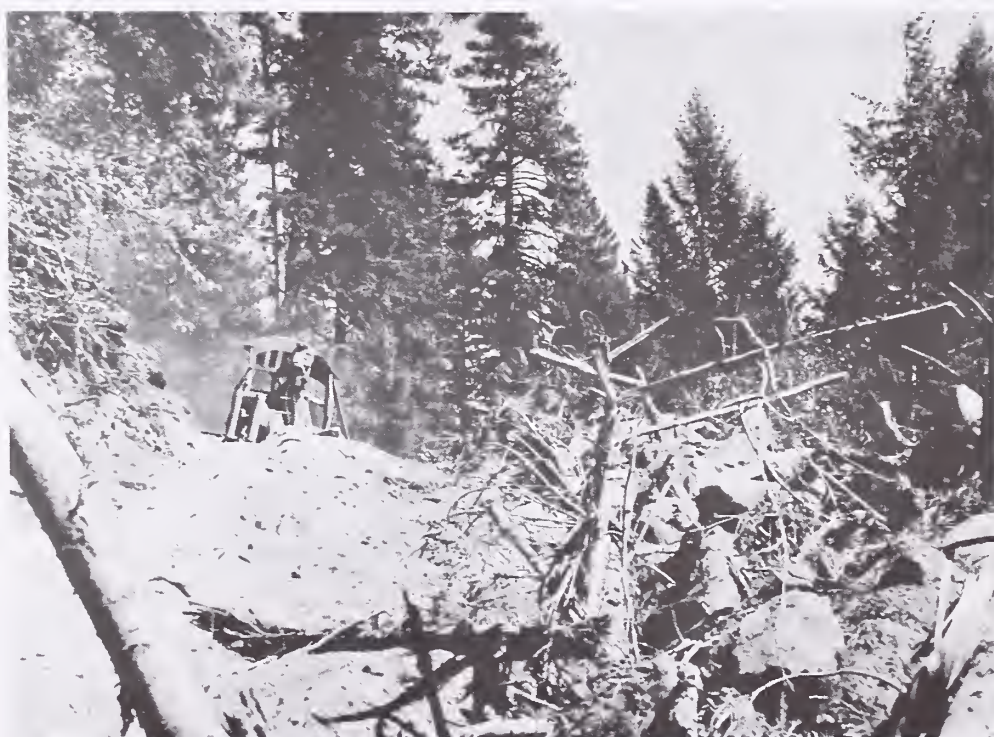
*Figure 2.--Slash and
organic debris mixed
with excavated
material.*

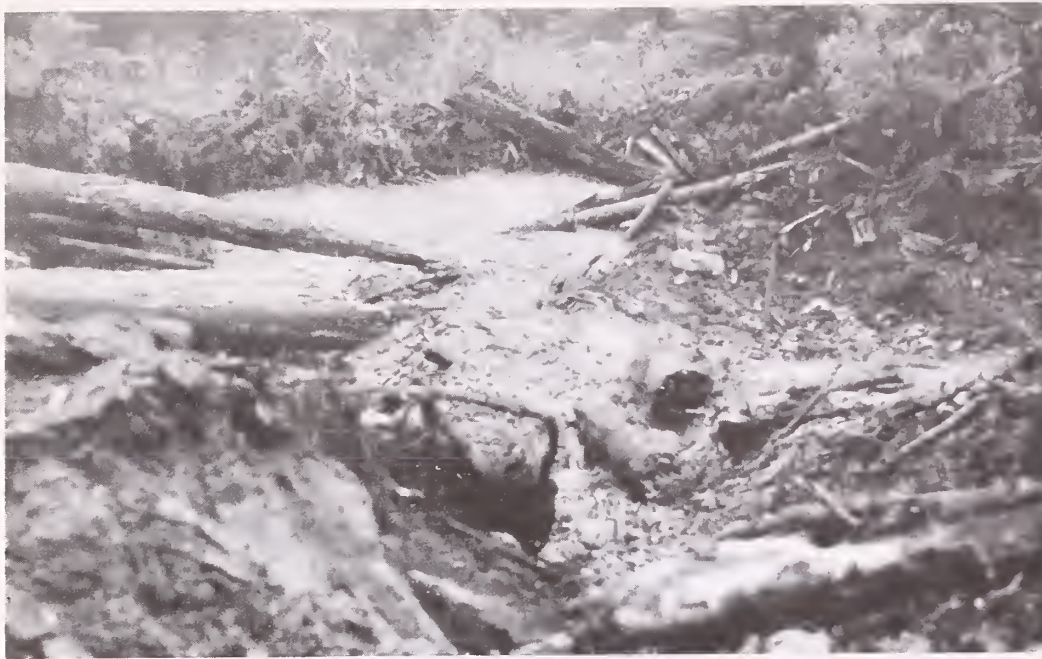
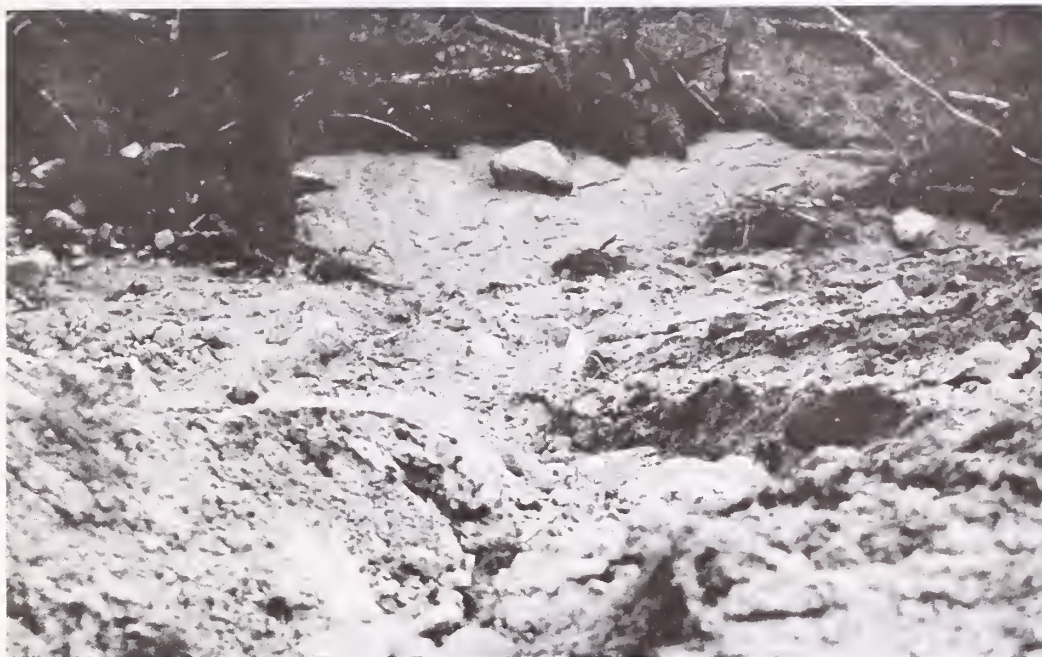
Figure 3.--Two examples of sediment trapped by windrowed slash.

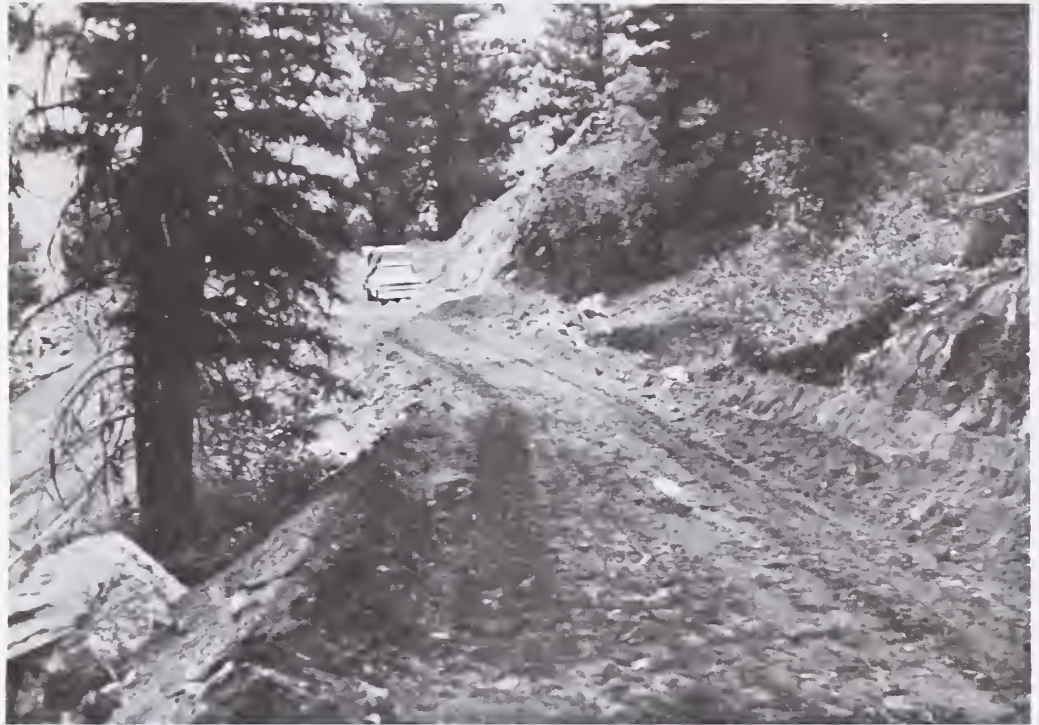
Such fills were often left to stand at the angle of repose (70-80 percent) instead of the angle (67 percent) specified by the design. These conditions could have contributed to sloughing and settlement cracks parallel to the fill shoulders and to erosion due to the Labor Day storm (not surprising when one considers the minimum amount of compactive effort and the range in moisture contents). Laboratory tests showed that

Figure 4.--Wide tractor blade drifts fills and leaves windrowed shoulders with little compaction.

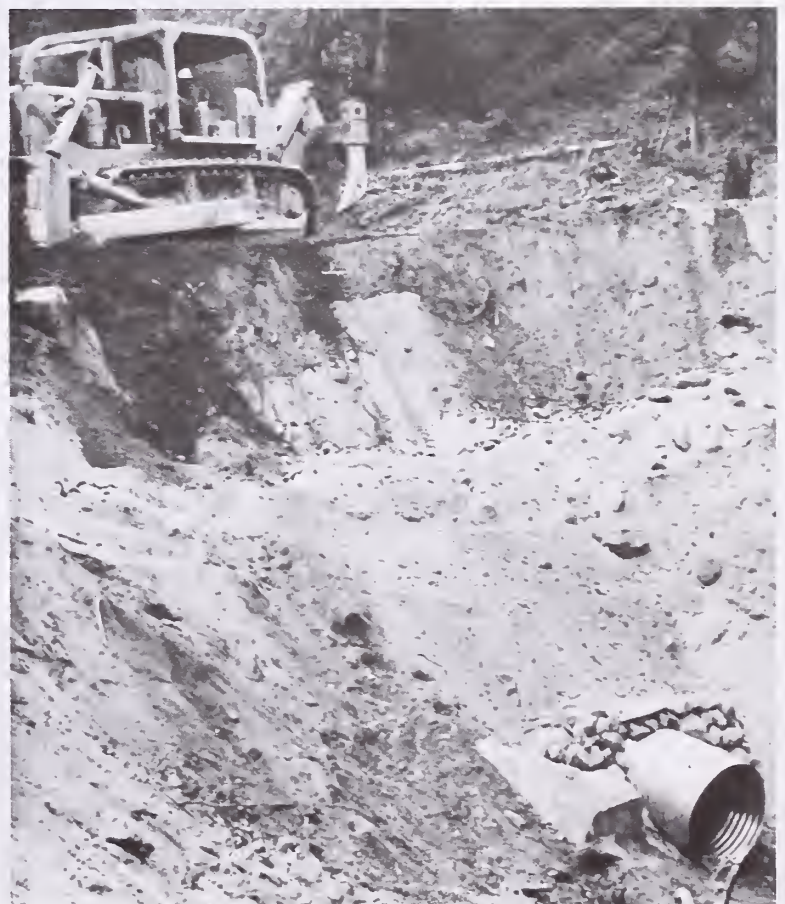
Figure 5.--Material is left in a loose, unstable condition when fills are sidecast.

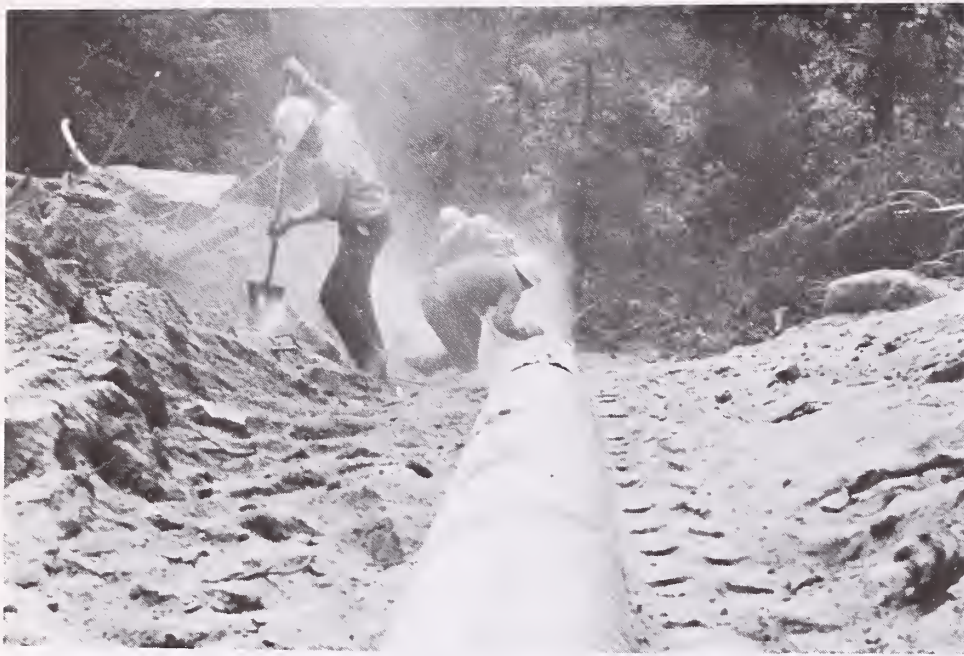
the optimum moisture content for compaction was 9.7 to 11.5 percent, but moisture contents measured in the fills ranged from 2.0 to 18.7 percent (figs. 6 and 7). Following the storm, areas on the cuts and fills evidenced the flow of soil, an indication that liquefaction had contributed to the erosion that occurred (fig. 8). The material on the surface of the cuts and fills was loose, probably in the range of 80 to 90 pounds per cubic foot (the loose unit weight according to the China Glenn Road Soils Report). Previous work done by Gardner and others² on similar type decomposed granitic soils in the Zena Creek area indicates that unit weights in this range would correspond to void ratios above the critical void ratio for these soils. Thus, the flow phenomenon was to have been expected under wet conditions.

Figure 6.--Dust from compactor indicates very dry soils.

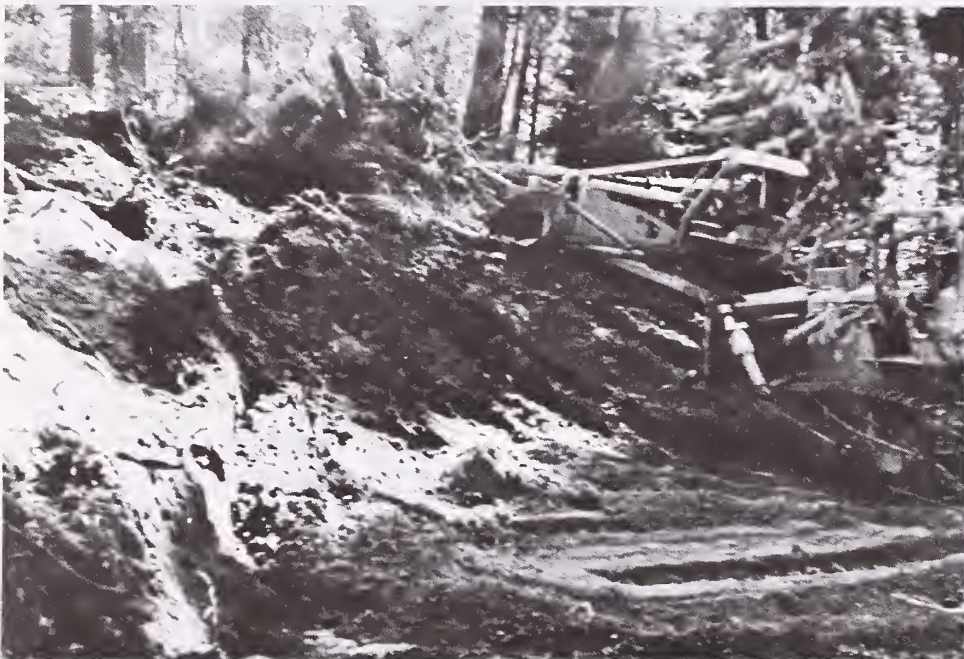
Figure 7.--Soils at stream crossings were saturated.

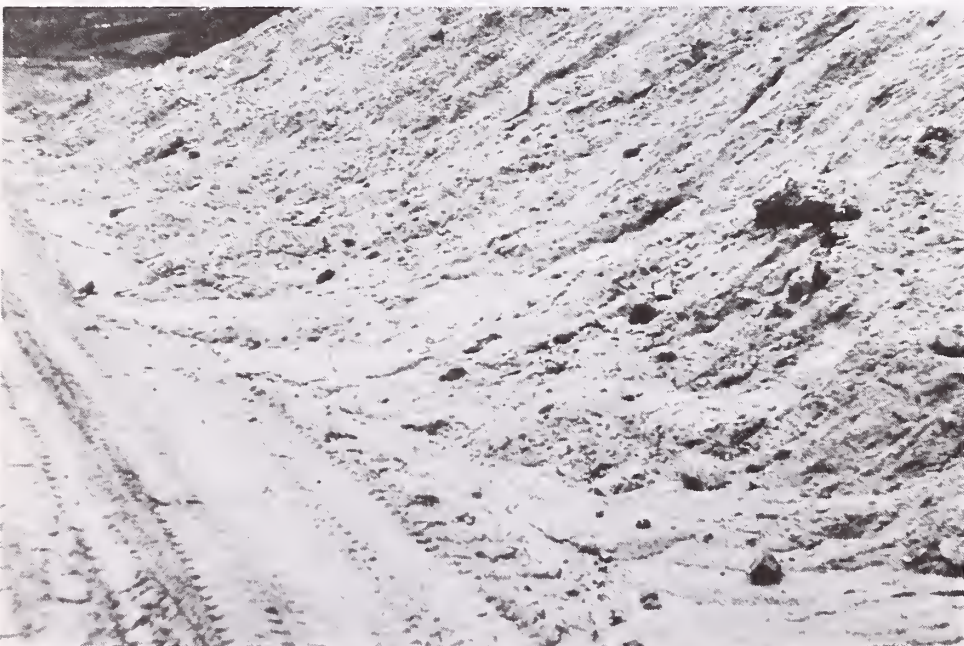
Figure 8.--Soil flows are apparent on this cut slope.

It is tentatively recommended that a grader complete with slope blade be used to remove loose materials, smooth slopes, and incorporate into the road surface the materials removed. Subsequent treatments to retard rapid disintegration and raveling would be desirable, but treatments now known are extremely expensive.

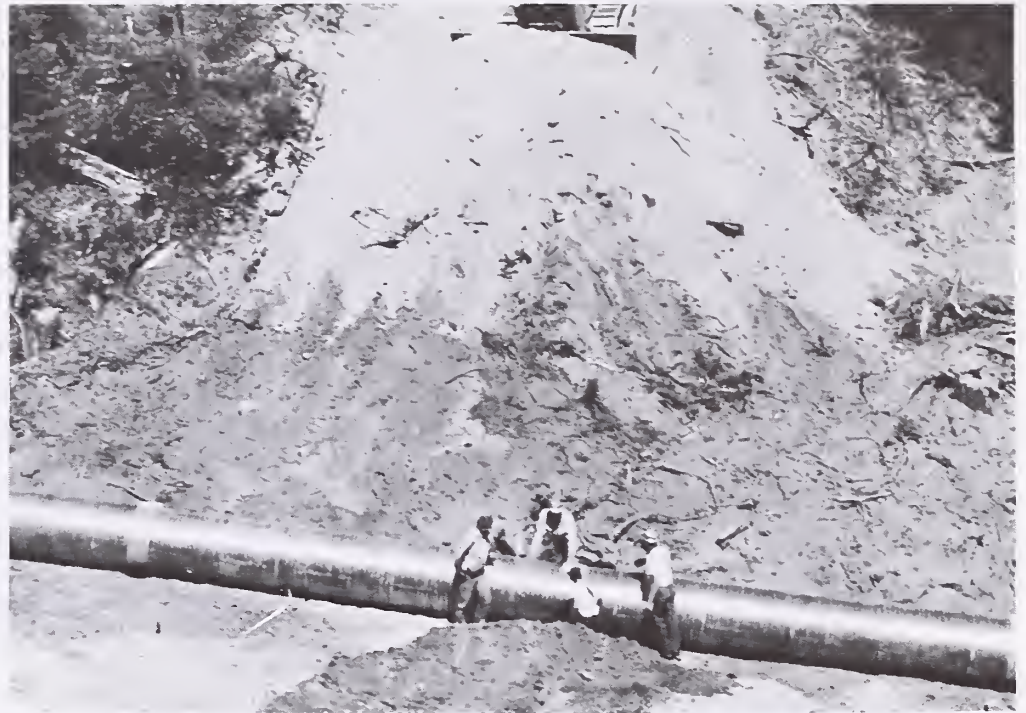
Figure 9.--Horizontal layer compaction is not being obtained in this fill.

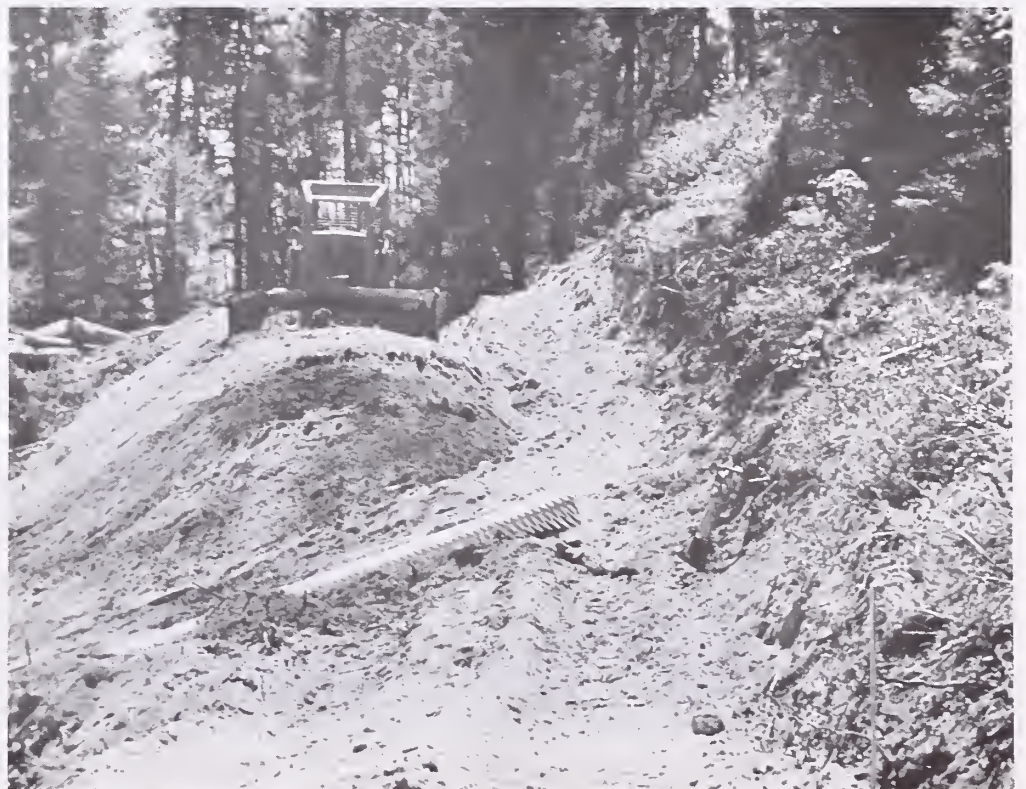
Figure 10.--Existing equipment makes horizontal layer placement difficult or impossible on steep side slopes.

Scrapers along with watering and rolling equipment could have produced a better embankment structure and, in cases of long balance points, probably would have been more economical. Some type of compaction on fill surfaces and other stabilization measures should be incorporated to hold fill material in place (fig. 11).

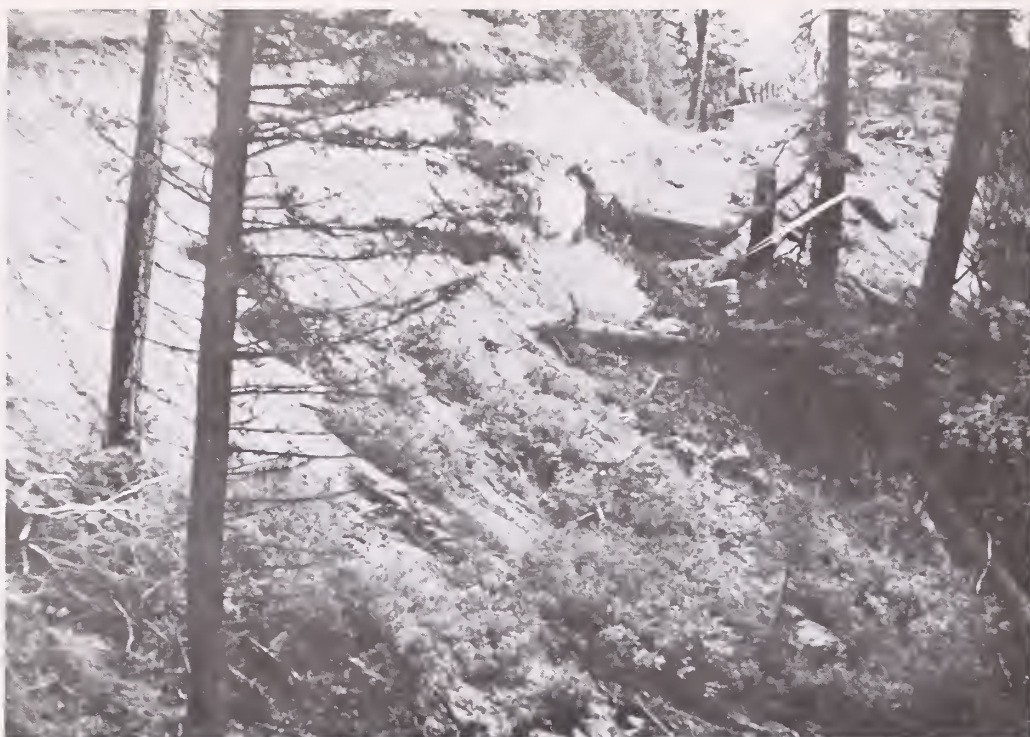
Figure 11.--Stabilization measures are needed to hold fill material in place.

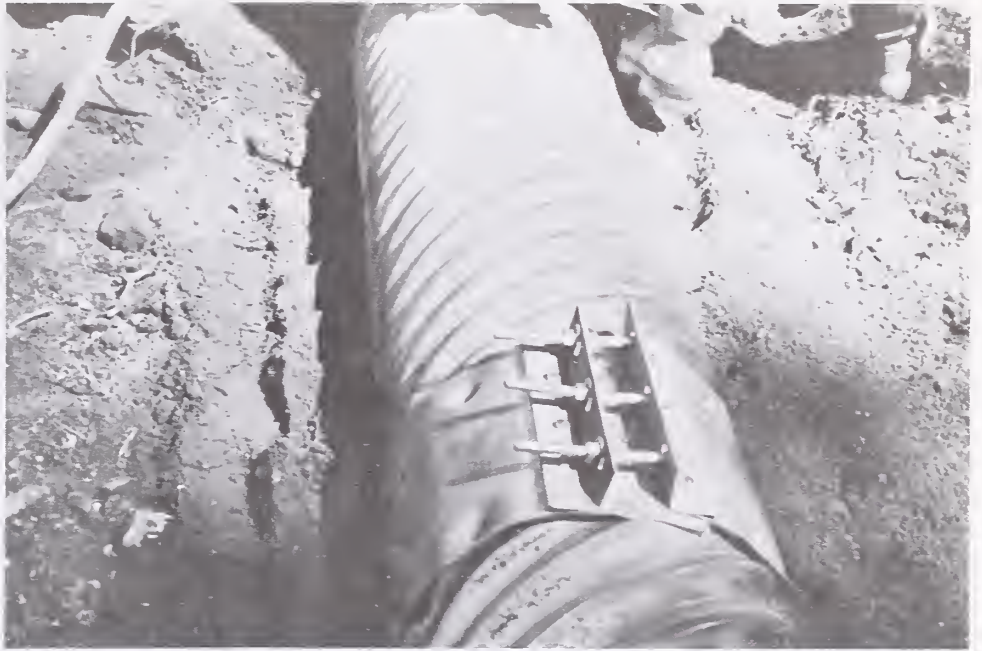
*Figure 12.--Dimpled
connecting band.*

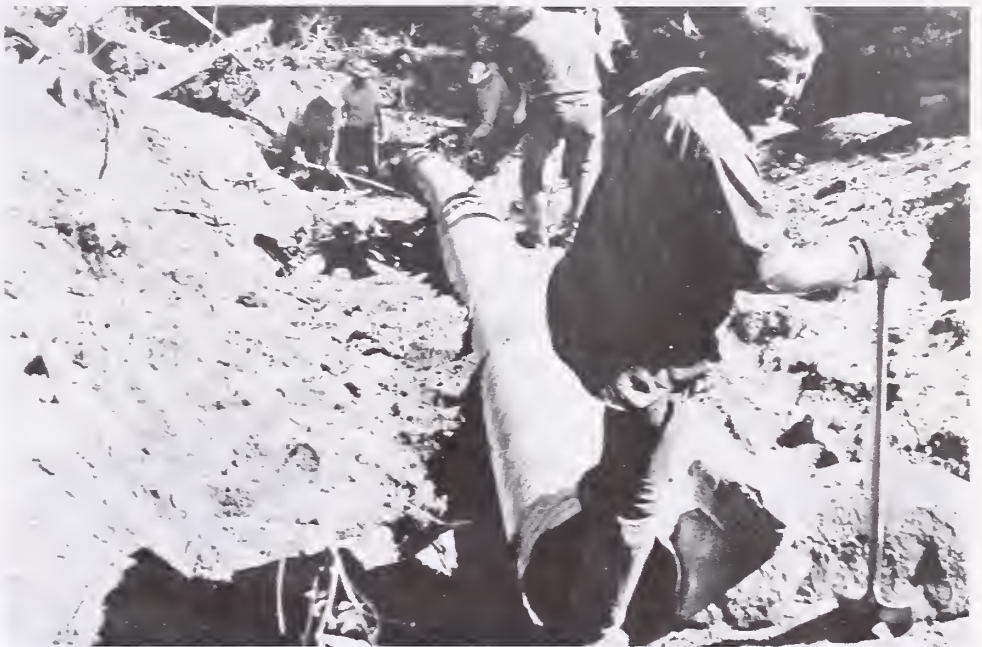
*Figure 13.--Steepness
of culverts could
be reduced by
skewing or using
downspouts.*

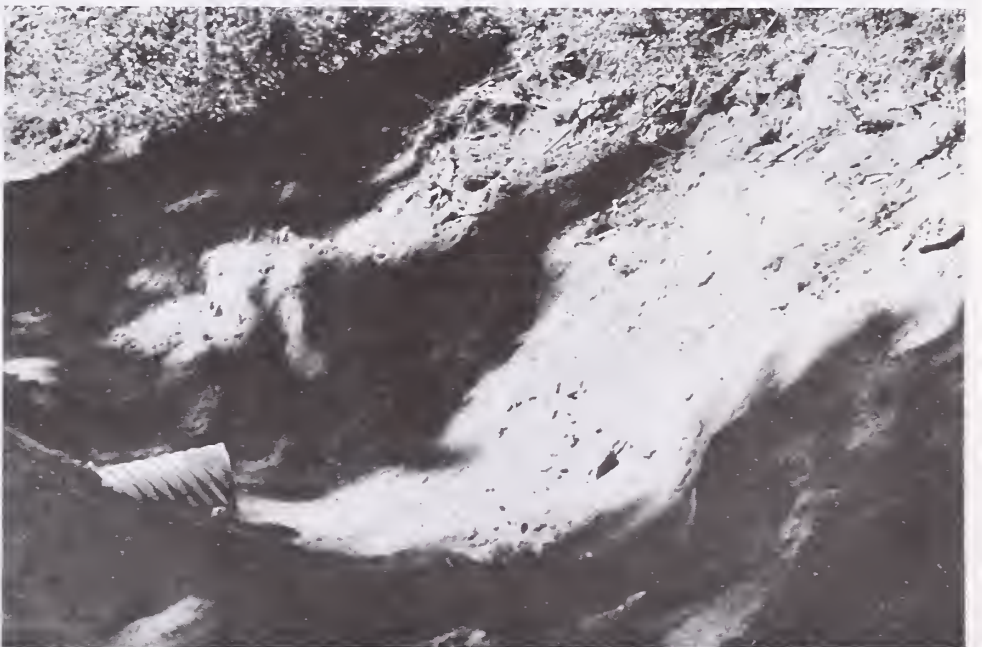
The flat-bottomed inlet ditch is of questionable value where small drainage areas are involved (fig. 14). The ditch will provide a sediment catchment at the culvert inlet, but it also opens up more of the hillside, which in turn causes more rapid erosion.

*Figure 14.--Flat-
bottomed inlet
ditch opens up
more of the
hillside.*

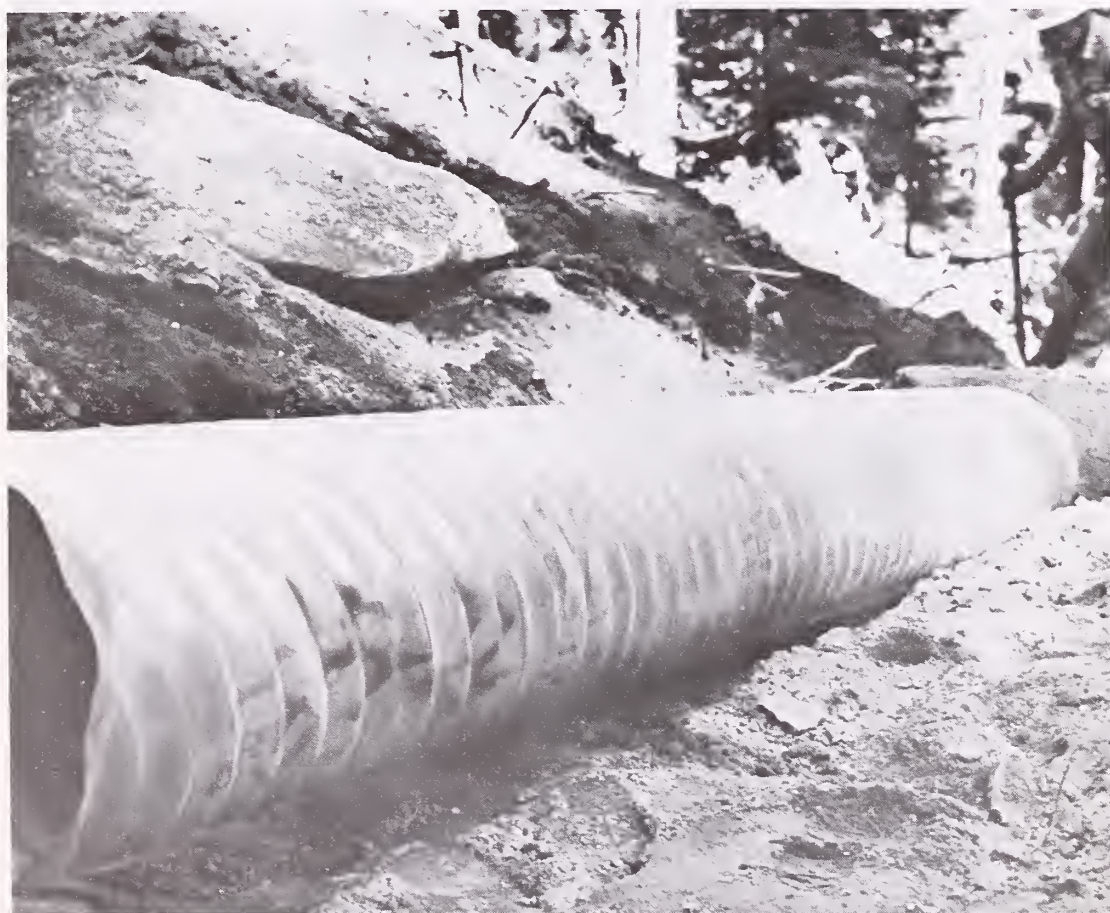
The bedding of culverts was generally good but, in a few cases beds were too deeply excavated, then backfilled to raise grade. It was observed on one of the small culverts that approximately the upper 8 feet of the culvert was not properly bedded before backfilling (fig. 15). The intent was to put camber into the culvert to allow for settlement; however, it is doubtful that 2 or 3 feet of fill would be heavy enough to hold the culvert in place. The authors believe that this practice could lead to pumping, piping, or to a flow path beneath the culvert. Camber should be accomplished by making a slight change in angle at the joints, not by bending the pipe. It is also recommended that camber be built in where settlements are largest, on the lower half of the culvert. Use of crawler tractors to excavate culvert beds disturbed natural stream channels above and below culvert installations. Use of a backhoe would allow excavation for proper bedding and avoid disturbing natural stream channels above and below culverts.

Figure 15.--The upper end of this culvert is not bedded properly.

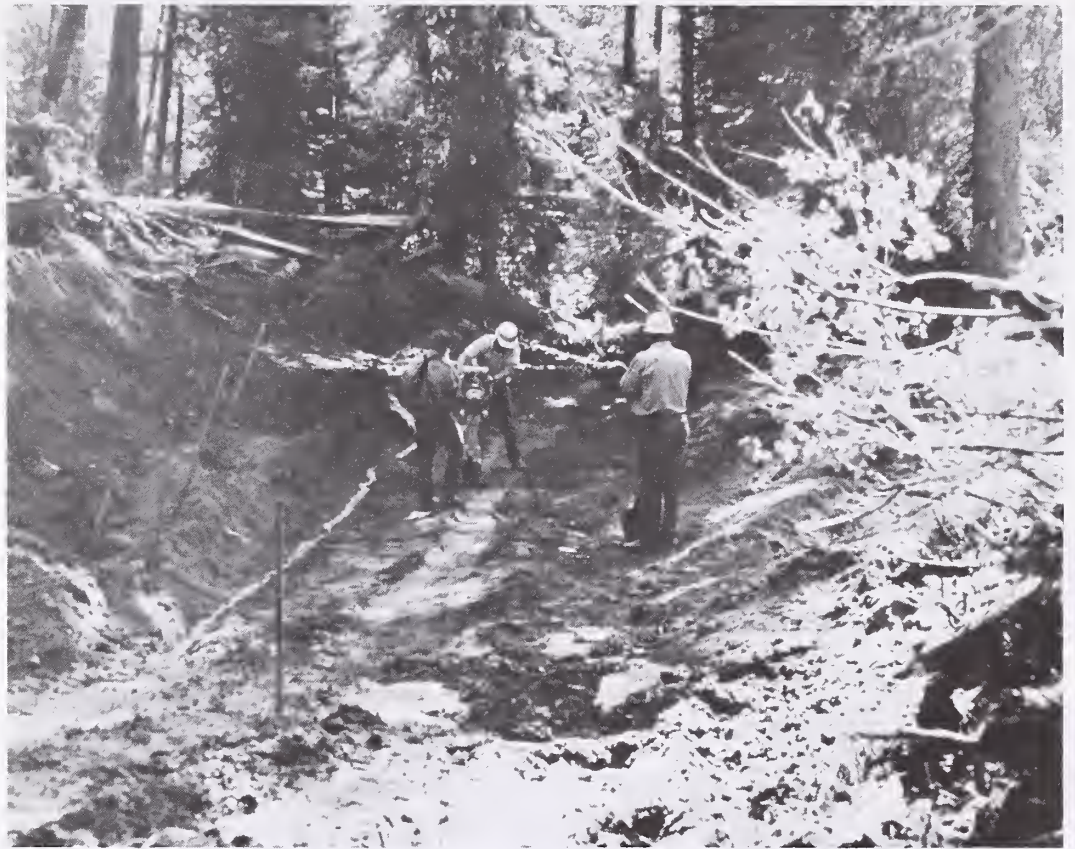
At least one culvert location had saturated soil that would have made poor backfill material. Fortunately, the inspector and the contractor agreed that the saturated material was to be mixed with drier soil (fig. 16) before being used for backfilling culverts. The specifications should be more specific concerning this important aspect of culvert installation.

Figure 16.--Saturated soils are replaced with drier soils for bedding and backfilling at this culvert installation site.

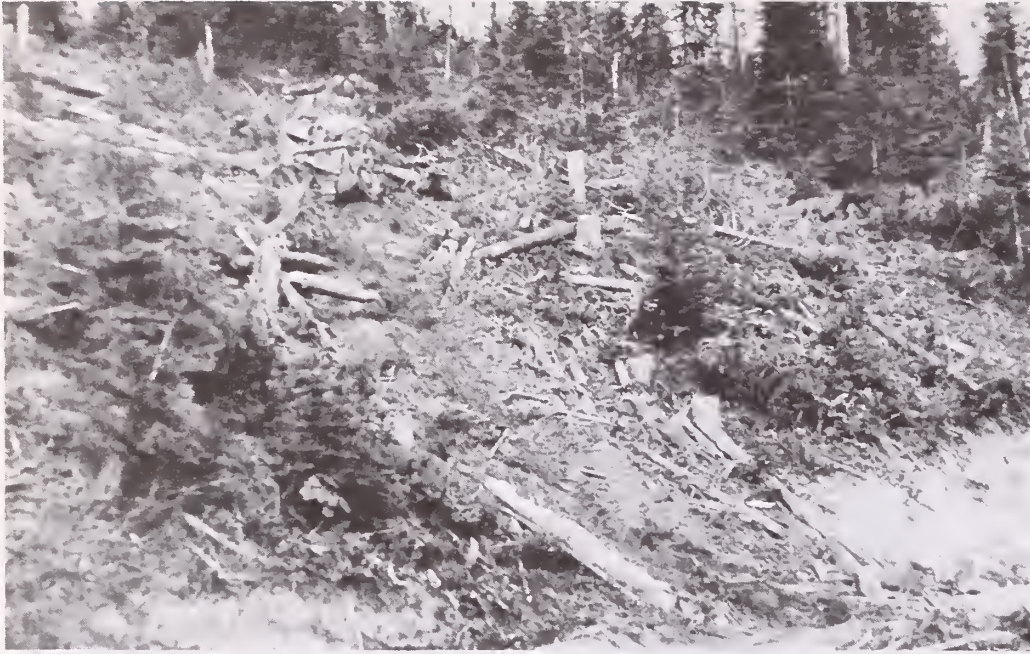
Figure 17.--Steep skid trails increase the erosion hazard.

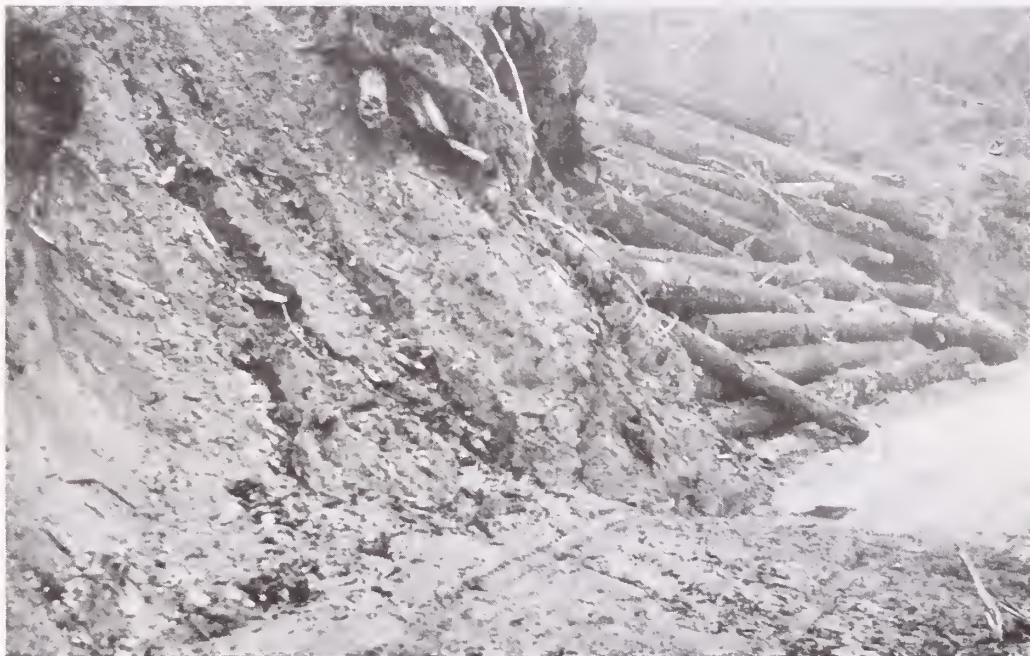
Figure 18.--Erosion and sedimentation produced by skid trail.

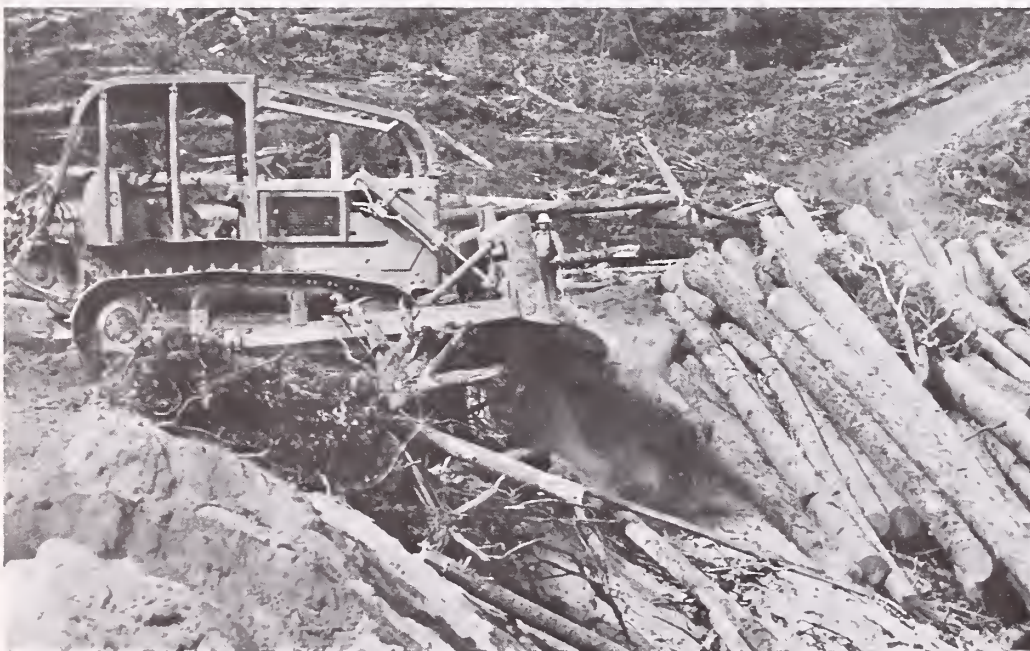
Figure 19.--Portions of road have been obliterated during logging operations.

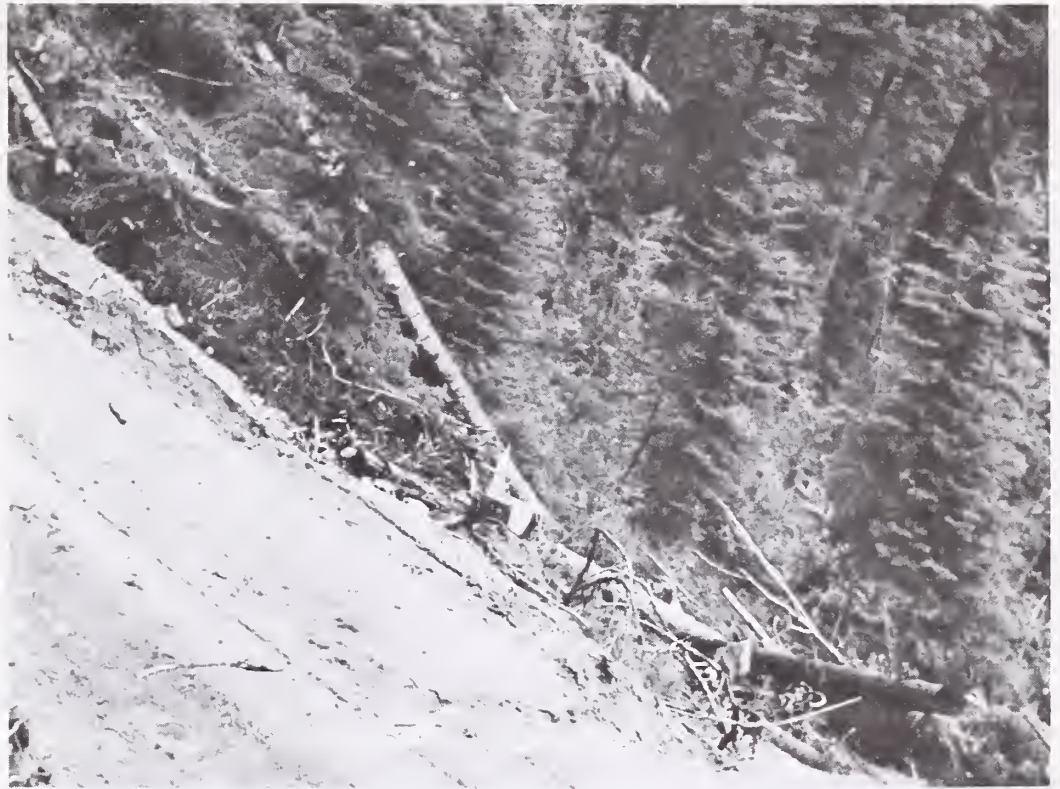
Figure 20.--Damage to fill was caused by water that ran down the road and over a low point in the fill.

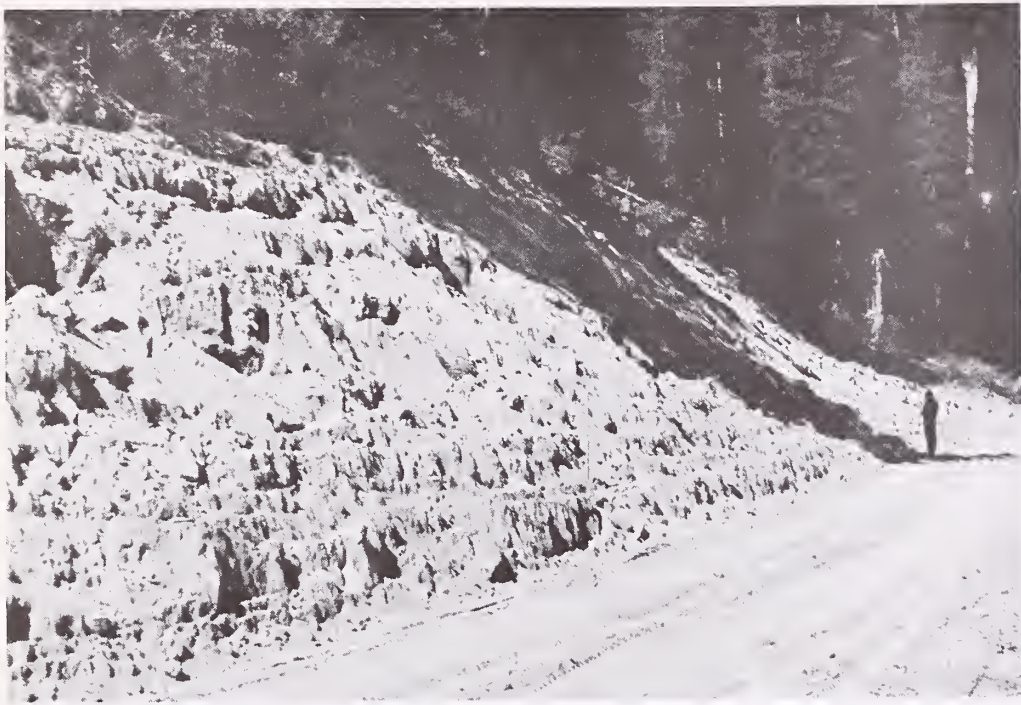
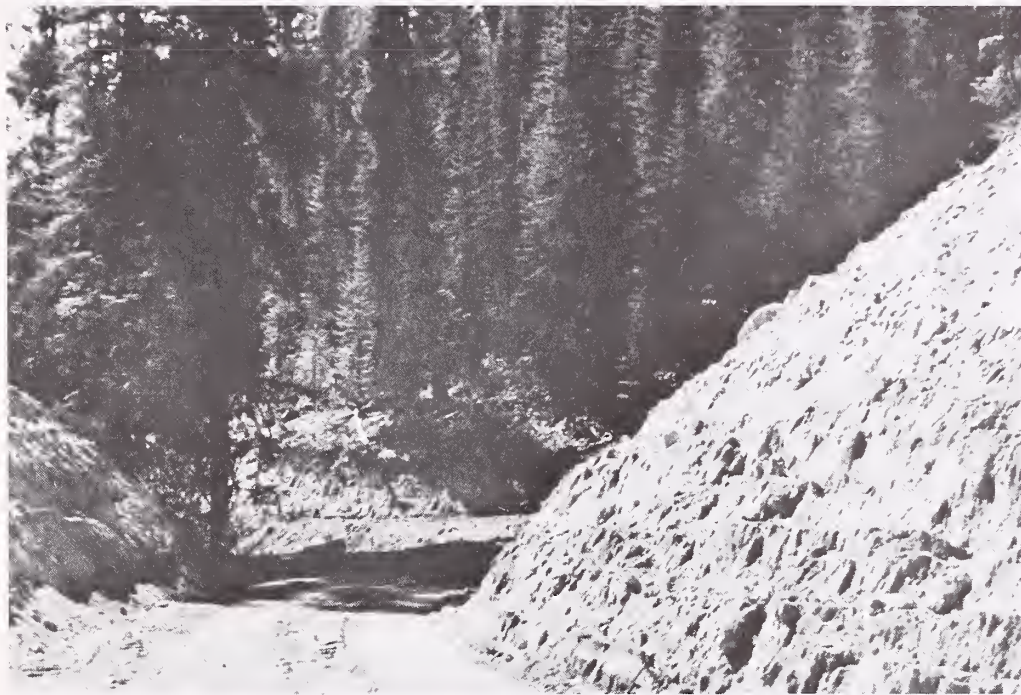
During field inspection, land managers expressed concern that the road would have more impact than had been anticipated. They felt that cuts and fills were larger than desirable or necessary (fig. 21). Apparently, they could not fully visualize the final product from the design sheets, which indicates a need for better communications. This

Figure 21.--Examples of large cuts, looking upstation (top) and downstation (bottom) from a point on the road.

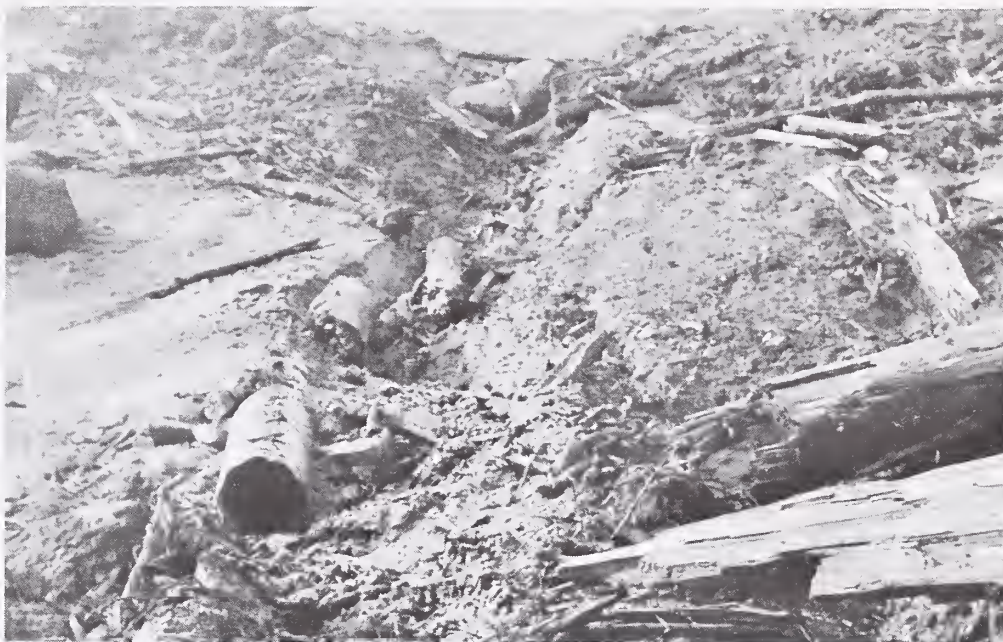
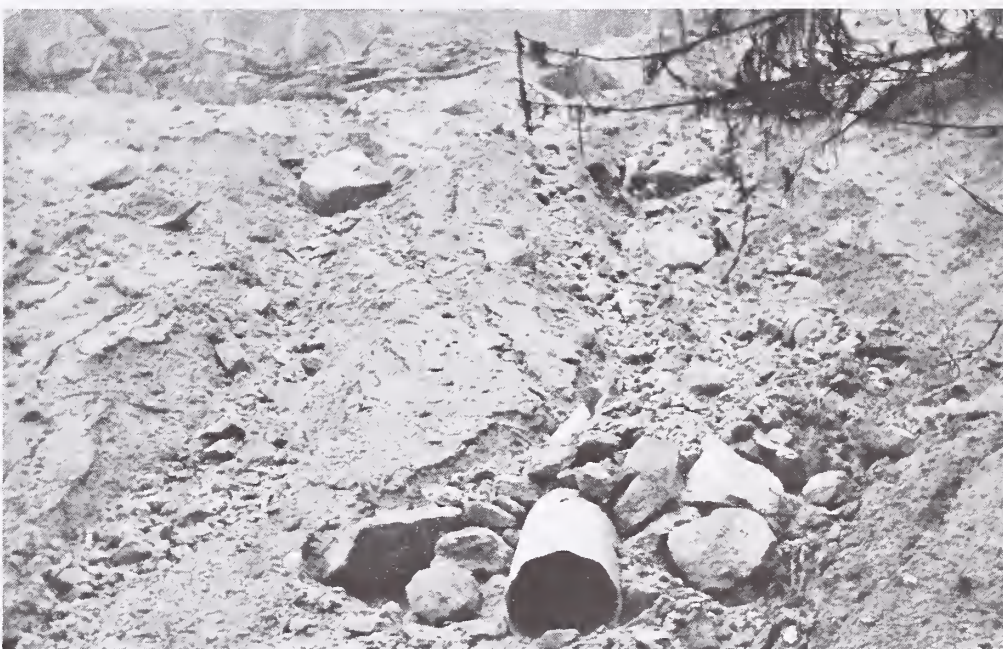
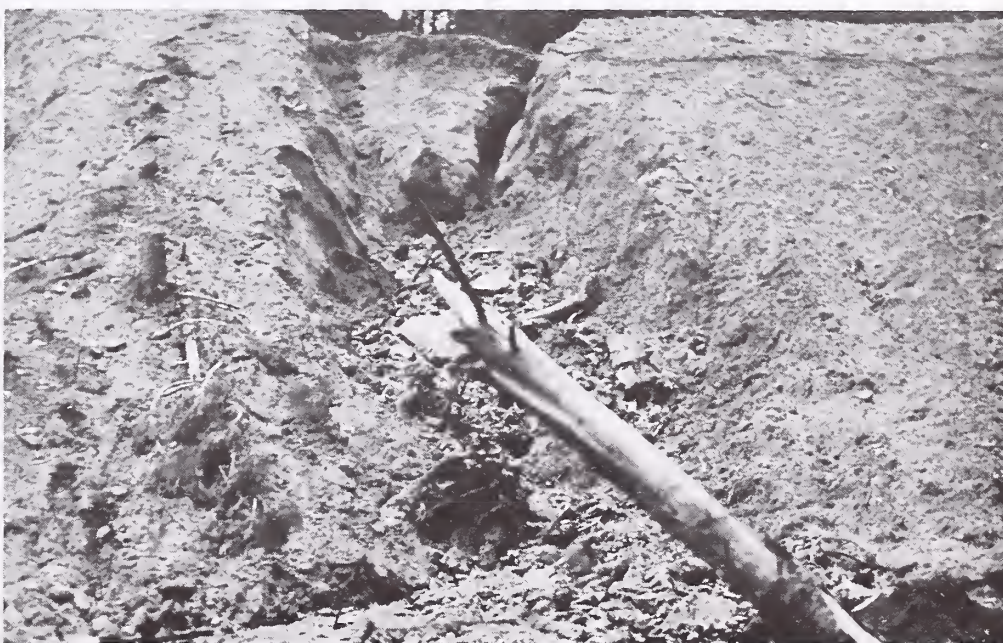
*Figure 22.--Three ex-
amples of damage
that occurred
during the
storm.*

The storm mentioned throughout this report served to point up problems that can result from road construction and logging in the Idaho Batholith. Culverts carried little or no water; so storm runoff due to overland flow was small. Water concentrations within the road prism and on logging skid trails did the damage (fig. 22).
